RE:

Inspection, County Canyon Mine, Ash Grove Cement, S/023/024, Juab,

Date of Inspection: June 26, 1992

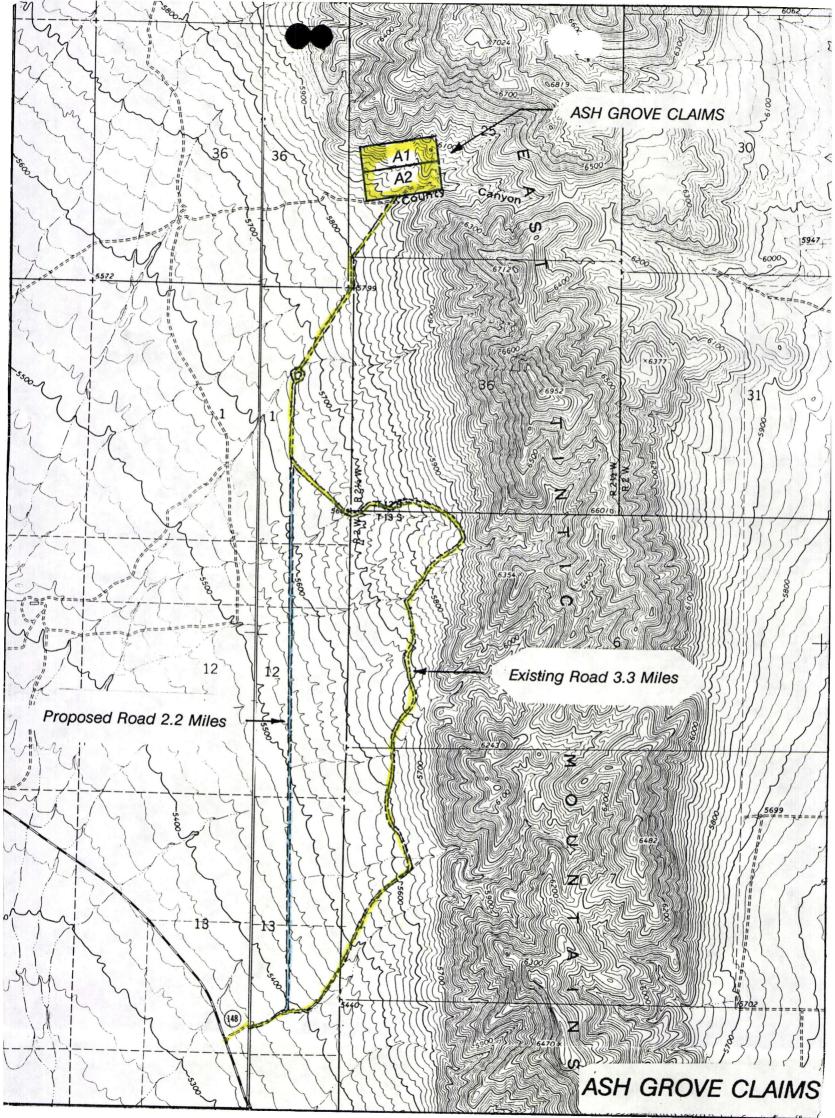
The purpose of this inspection was to evaluate the site of a new mine quarry and access road currently proposed by Ash Grove. The approximate location of the site is T12S, R2.5W, Sec. 25. The disturbance will include a quarry and about 3 miles of access road (see attached map).

First portion of the inspection involved a look at the site of the quarry. The quarry has been initiated and currently disturbs @1/2 acre. The operator intends to disturb @6 to 8 acres before the project is complete. The quarry disturbance is entirely on BLM lands (see attachment).
